## DE30 / Engine Dynamometer

### DE30 Eddy Current Engine Dynamometer

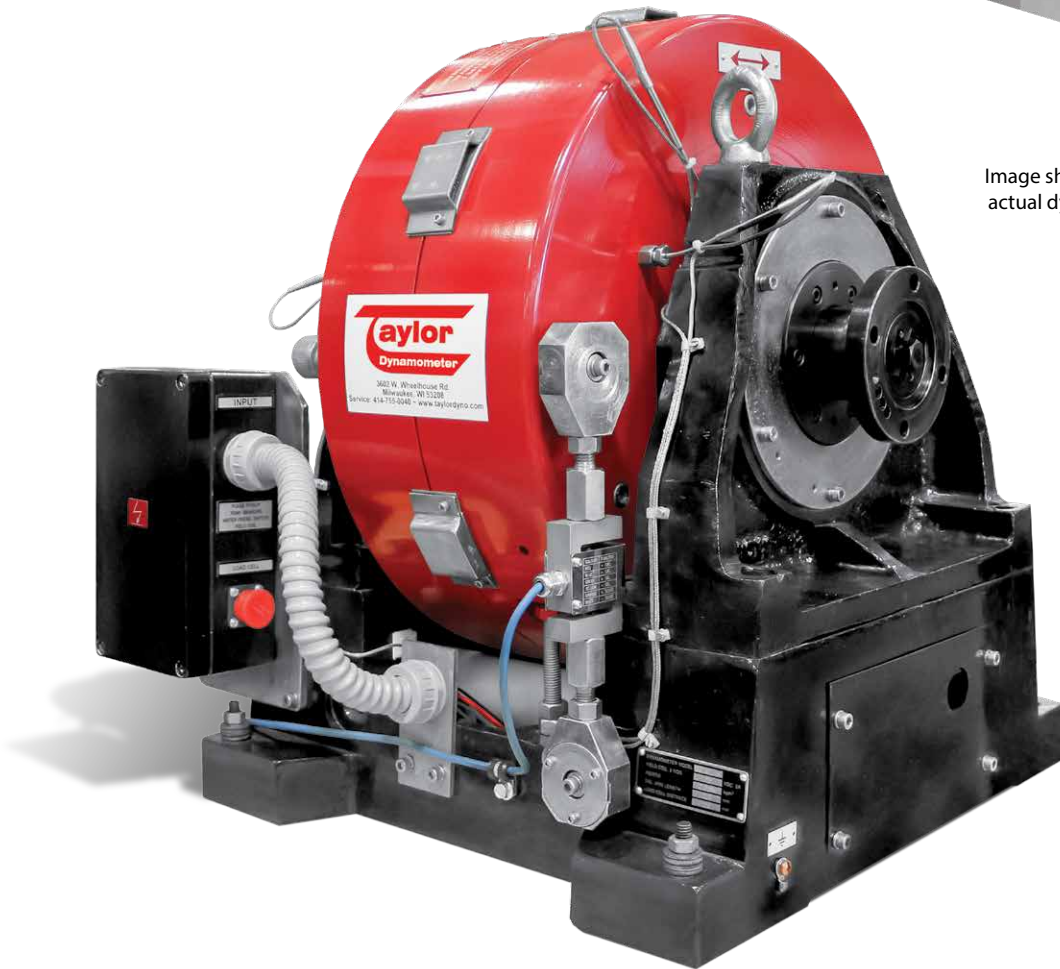
Image shown is for display only, actual dynamometer may vary.

Power:	40 hp (30 kW)
Torque:	70 lb-ft (95 Nm)
Speed:	14,000 rpm
Water Use*:	10 gpm (37.9 lpm)
Inertia Value:	0.40 lb·ft <sup>2</sup> (0.0168 kg·m <sup>2</sup> )
Shipping Weight:	1,213 lb (550 kg)
Rotation:	bi-directional

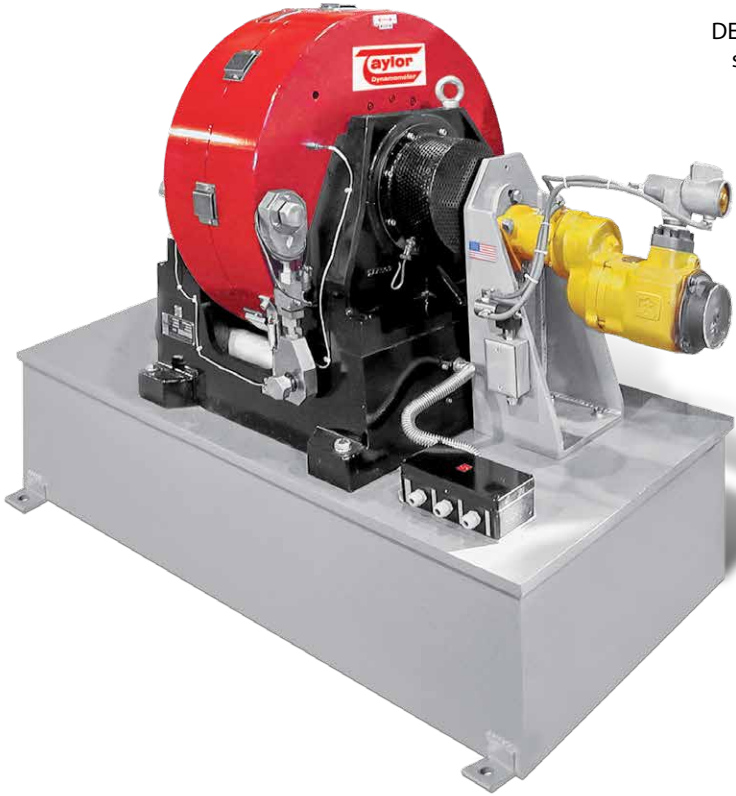
DE250 shown with optional sub-base and air starter
