## DE500 / Engine Dynamometer

## DE500 Eddy Current Engine Dynamometer

SMS2032v007

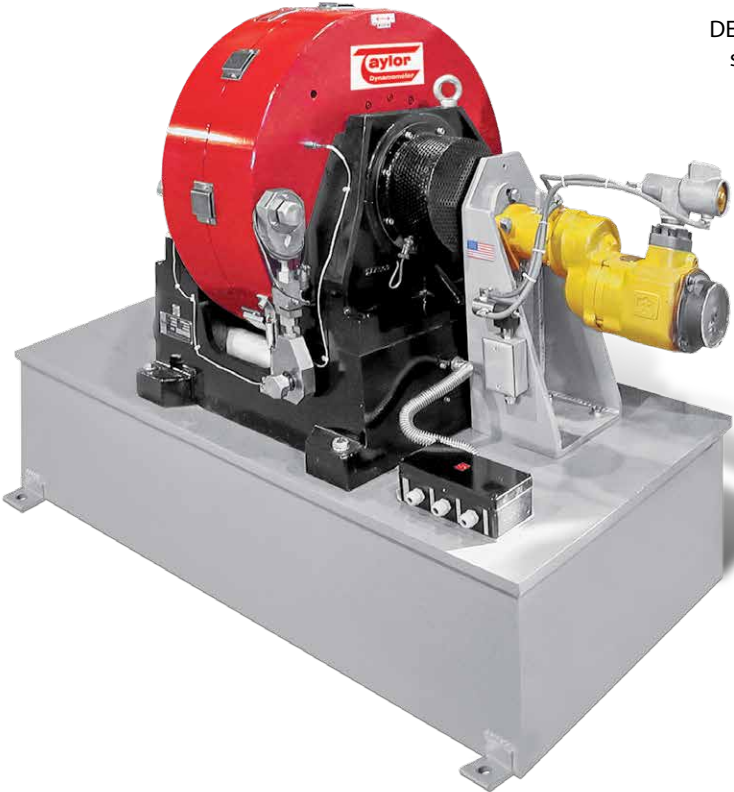
DE250 shown with optional sub-base and air starter

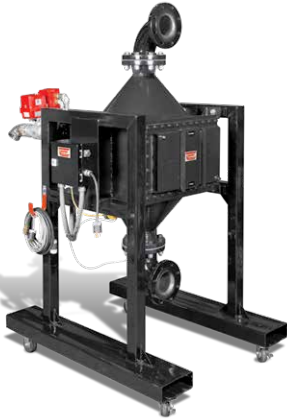
Optional Charge Air Cooler
