## DE720 / Engine Dynamometer

## DE720 Eddy Current Engine Dynamometer

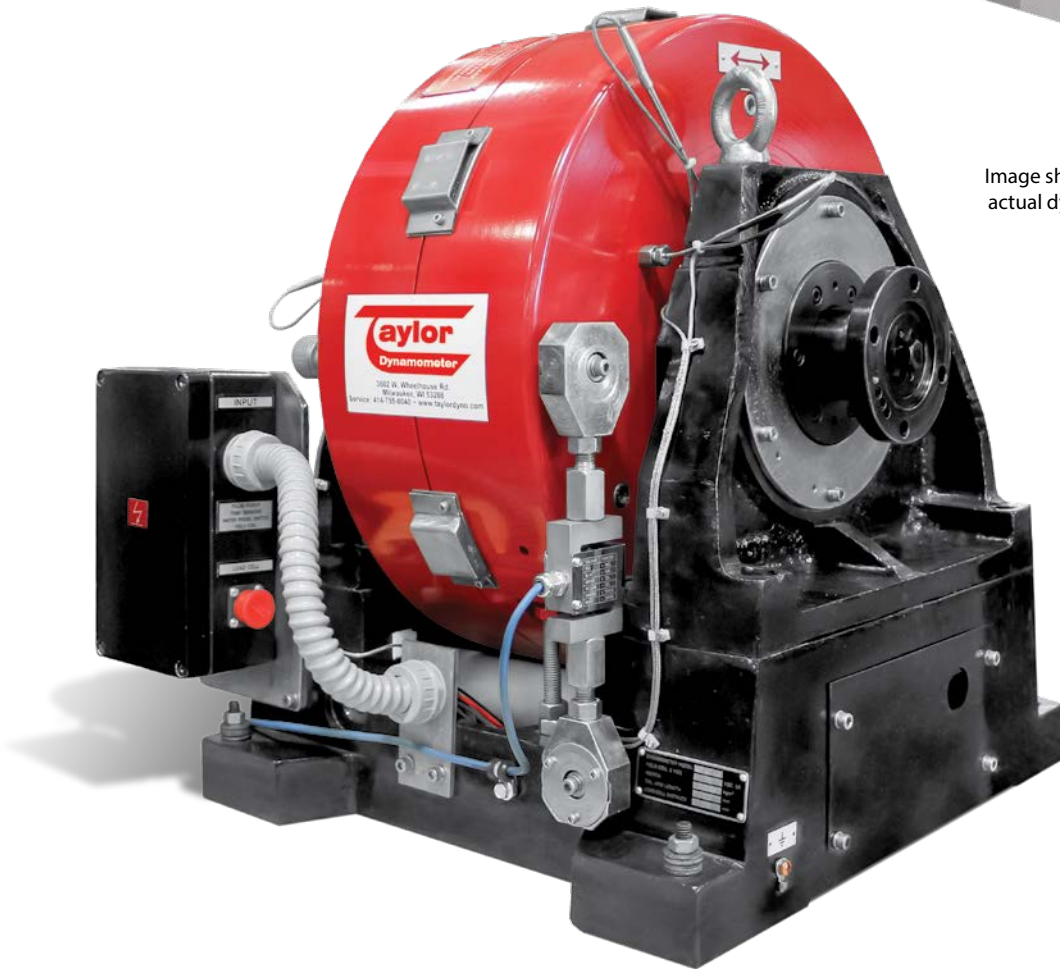
Image shown is for display only, actual dynamometer may vary.

Power:	966 hp (720 kW)
Torque:	3,320 lb-ft (4,500 Nm)
Speed:	3,750 rpm
Water Use*:	124 gpm (469.4 lpm)
Inertia Value:	126 lb·ft <sup>2</sup> (5.3 kg·m <sup>2</sup> )
Shipping Weight:	9,259 lb (4,200 kg)
Rotation:	bi-directional

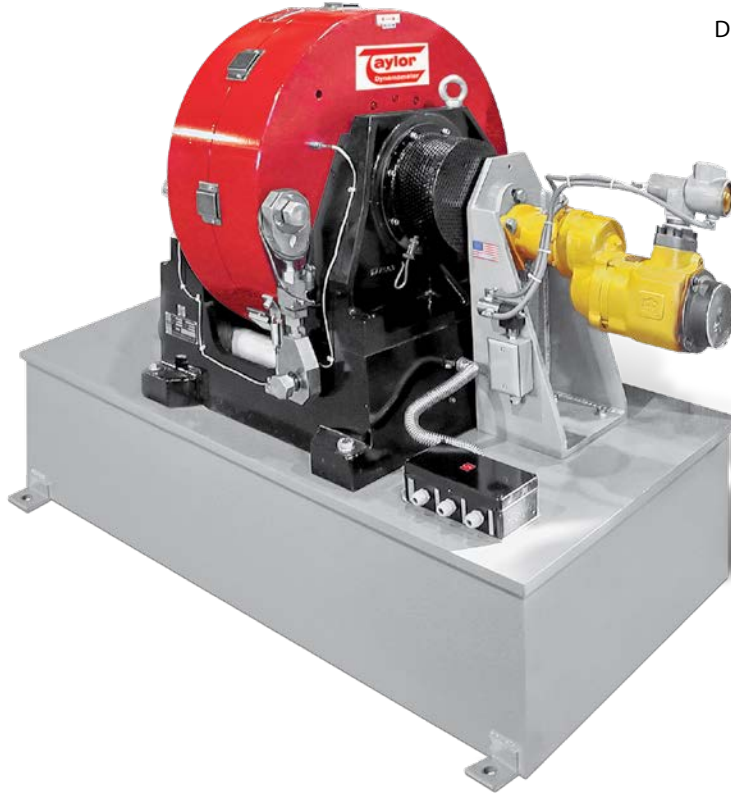
DE250 shown with optional sub-base and air starter

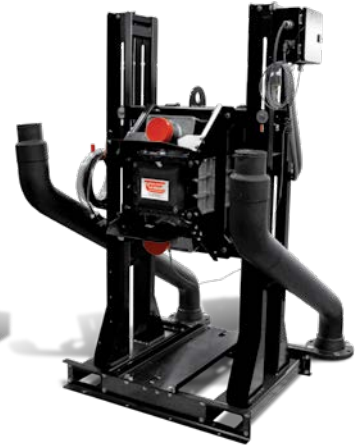
Optional Charge Air Cooler
