DL700 / Engine Dynamometer

DL700 Water Brake Dynamometer

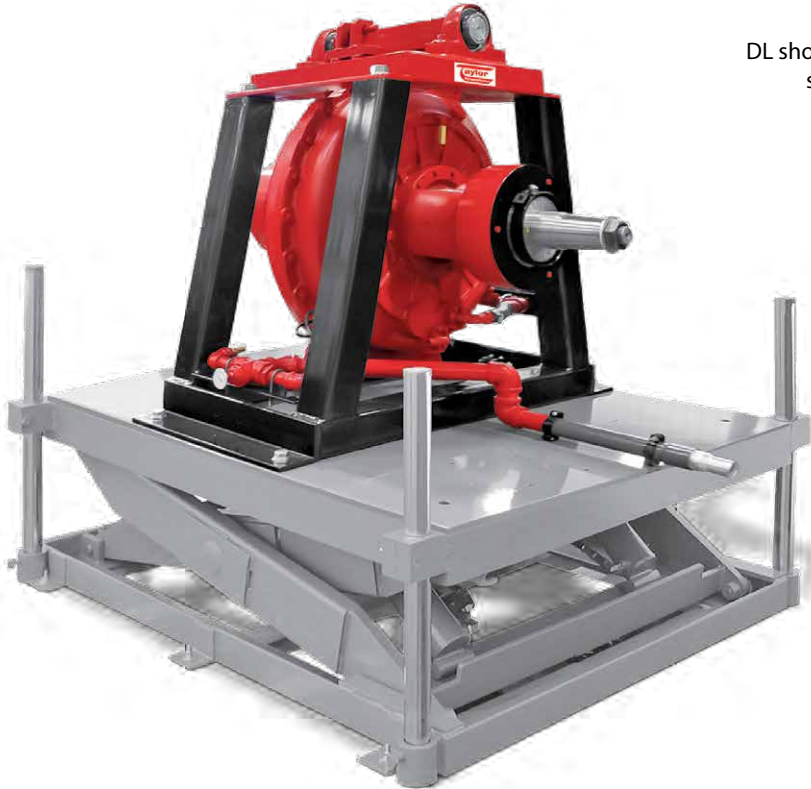
DL shown with optional scissor base

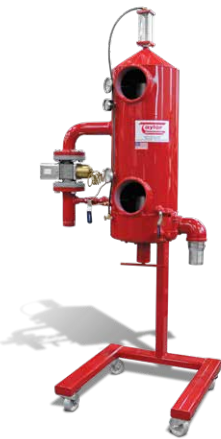
Optional Cooling Column

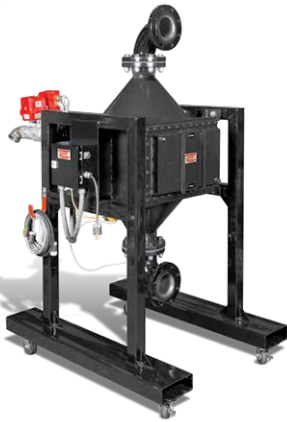
Optional Charge Air Cooler
